1428

**Estrattori per dadi destrorsi danneggiati con attacco quadro**

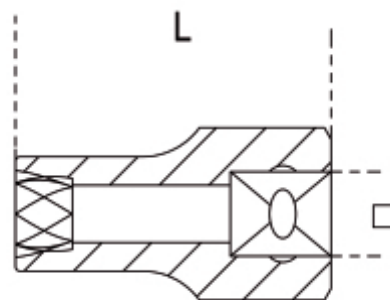
- Lo speciale profilo conico garantisce una forte presa in fase di disserraggio
